PHOTOGRAPHIC INTERPRETATION REPORT

**DNEPROPETROVSK MISSILE DEVELOPMENT
AND PRODUCTION CENTER
DNEPROPETROVSK, USSR**

JUNE 1966
COPY 101
20 PAGES

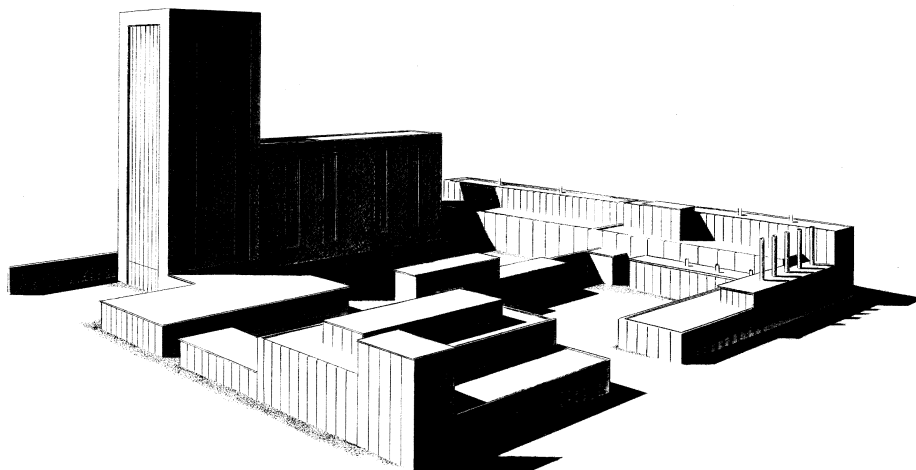
FIGURE 5. ARTIST'S CONCEPTION OF POSSIBLE TESTING/ASSEMBLY AND CHECKOUT BUILDING (item 12, Figure 4).

Item 5 has a tower section measuring [redacted] which rises 100 feet above the building roof, indicating a vertical missile airframe assembly operation or possibly the manufacture, test, and assembly of tanks and pipe systems. Item 12 (Figure 5) is a complex structure with an integral tower section forming one corner; the tower measures 55 feet square and 135 feet high. Hydrostatic testing of missile tanks, alignment testing, or vertical assembly and checkout seem to be the most likely operations in this structure.

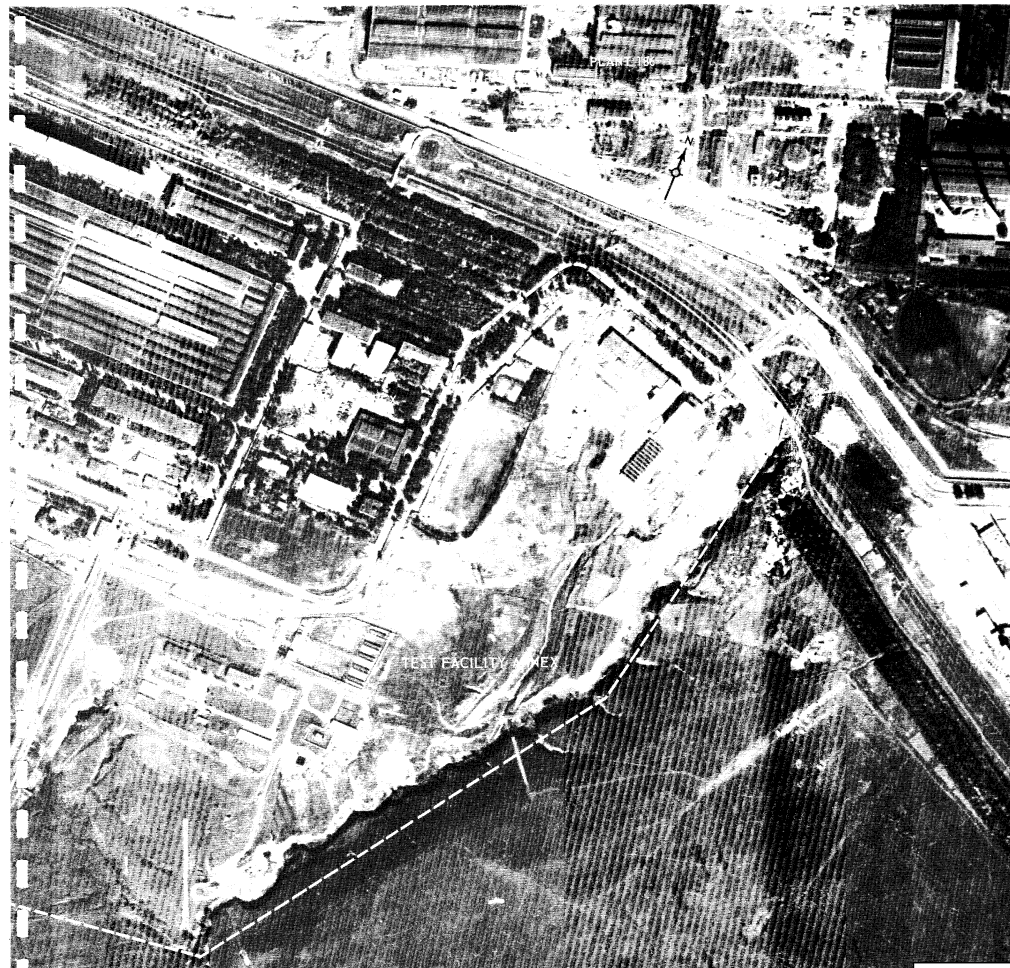
test complex. Because item 12 is essentially identical to item 11, the following description of the latter will also apply to item 12. The most prominent part of item 11 is a central tower section approximately [] this is flanked on the west by a section measuring [] feet high and on the east by a T-shaped section about 80 feet long. These support structures are connected to the tower section or closely adjacent to it. The tower section consists of 2 separate vertical elements joined at the top by a rectangular box-like structure; a tall metal pipe or stack protrudes from the top of the tower section. The vent pipe on item 12 may have a T-shaped configuration at or near its top. Two tanklike objects were visible in [] adjacent to item 11, apparently lying on the ground or on low cradles. In addition to the 2 principal structures, each of the duplicate facilities also includes a protected battery of probable high-pressure tanks, a small separate building, and a concrete-lined rectangular sump or pit which may have a pump housing at its bottom. The combination of sumps, water supplies, gas pressure systems, and tall slender towers indicates that these facilities are involved in hydrostatic and/or flow calibration testing.

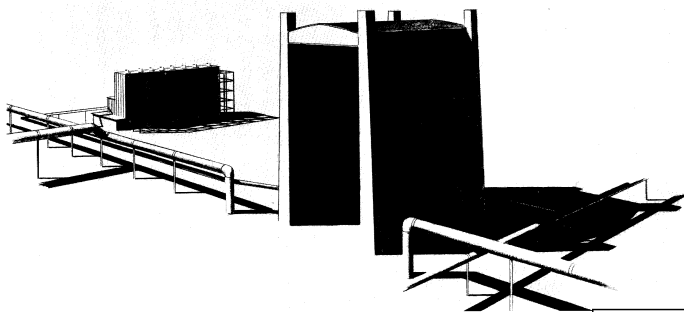
FIGURE 9. ARTIST'S CONCEPTION OF POSSIBLE STRUCTURAL TEST FACILITY AND POSSIBLE HYDROSTATIC OR STRUCTURAL/VIBRATION TEST FACILITY (items 2 and 6, Figure 8).

Item 2 is a complex 3-level structure surrounded by a heavy-duty loop road system (Figure 9). A probable steamline enters the south side of the building, and 8 ventilators are visible on the roof of the highest of the 3 levels. A large open steel framework is attached to the east side of the building, the top of the framework being a few feet lower than the highest roof level. This framework extends along the entire length of the building and may be either a framework to support missiles/stages for structural testing or an addition still under construction. The former is more probable because of the presence of an apparent drive-through road. At least 4 columnar objects with open ends are evenly spaced at the juncture of the building proper and the open steel framework. The tops of the columns are just below the level of the top of the "roof" section of the framework.

Item 6, a large structure measuring 110 by 50 feet by 100 feet high, appeared to be incomplete in [REDACTED] the north and south ends were open, and the roof was not complete (Figure 9). The long walls are probably vertical, but they may slope inward slightly toward the top. The large-diameter overhead probable water pipeline, which originates outside the secured area west and south of item 6, is buried under the ground from a point just west of the building to a point immediately east of it, probably because the pipeline interfered with construction of item 6; a large feeder line from the overhead pipeline may enter the west side of the building. Three large horizontal tanks, two measuring [REDACTED] were visible on the ground approximately 160 feet southeast of the building; these could be fuel/oxidizer tanks or missile airframes. There appear to be buttresses or columns at the outside corners of the building. The apparently large-capacity water source is an indication that item 6 possibly is or will be involved with hydrostatic testing of some type; however, the size and configuration of the building indicate probable structural/vibration testing.

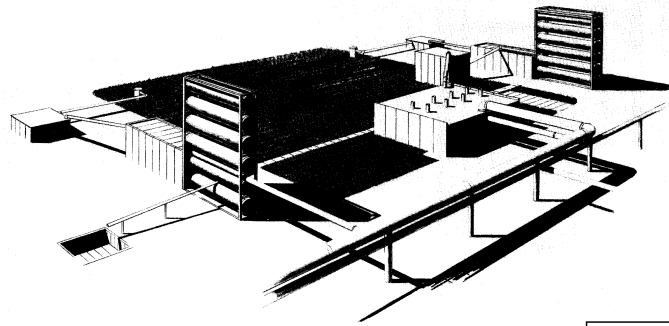
FIGURE 10. ARTIST'S CONCEPTION OF DUPLICATE PROBABLE CALIBRATION TEST FACILITIES (items 4 and 5, Figure 8).

Items 4 and 5 are the tallest structures in a group of buildings situated around a loop road (Figure 10). This group comprises 2 duplicate test facilities on opposite sides of a central building located at the junction of the loop road with the Test Facility road system. Items 4 and 5 are each probably a vertical arrangement of 5 to 7 large, horizontal, low-pressure tanks stacked one above the other. In addition to one of these tall structures, each of the duplicate facilities also includes 3 buildings, a small vertical tank or very small building, and a lined rectangular sump or pit; all the structures in each facility are interconnected by overhead water and/or steam pipelines. The central building, probably housing compressors or pumps, measures 60 by 45 feet and has 8 thin pipe stacks or vents projecting through the roof. The heavy-duty loop road widens to form paved parking aprons on all sides of

items 4 and 5. A precise identification of this pair of facilities cannot be made; however, the apparent utilization of fluids in quantity leads to the conclusion that these are probably calibration test facilities.

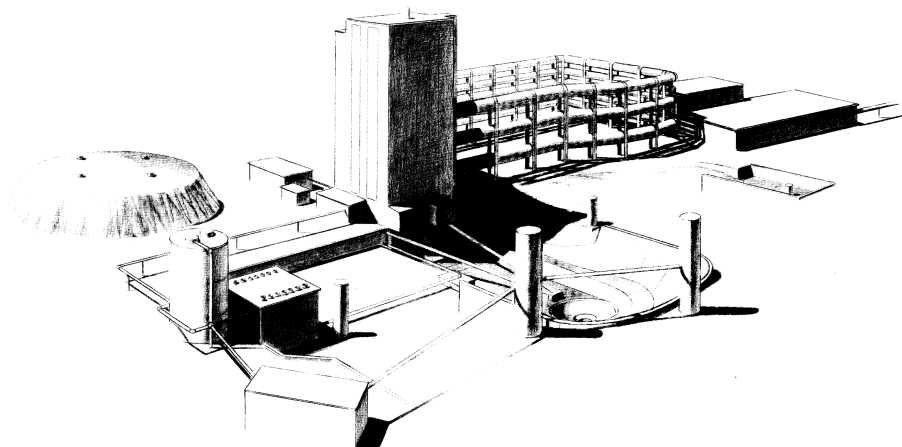
FIGURE 11. ARTIST'S CONCEPTION OF PROBABLE CALIBRATION TEST FACILITY (items 14 and 15, Figure 8).

Items 14 and 15 are the principal structures in a probable calibration test facility (Figure 11). The test tower (item 15) is linked to item 14 by a large, elaborate pipe gallery, 3 pipes high on the east side and 6 pipes high on the west. In addition to items 14 and 15, the following are also associated with this facility: 3 slender vertical tanks interconnected by overhead piping which is connected to the test tower, several small buildings, a large earth-mounded tank, and a large 2-row battery of probable high-pressure tanks enclosed on 3 sides by high concrete walls. The test tower is approximately 110 feet high; the top measures 40 by 30 feet and has 2 levels, the higher part being on the east side facing an inclined trough below. The trough conducts fluids into a probable collection sump, the bottom of which is approximately [redacted] below local grade level. At least 2 pipelines connect the base of the test tower and the sump, and there is a small building which may be a pumphouse at the lip of the sump; this system appears to be designed to recover the fluids used in testing. Item 14 appears to be the terminus of the pipeline that originates at item 13b, which is probably the source of the fluids carried in the pipeline; the path of the fluids from item 14 into the test tower is not discernible. The corral-like pipe gallery may carry the fluids from item 14, or this unusual collection of piping may be utilized to return expended fluids from the collection sump. The purpose of this pipe gallery appears to be related to the heat/pressure/state-of-matter of gases or cryogenics or a storable oxidizer such as nitrogen tetroxide.

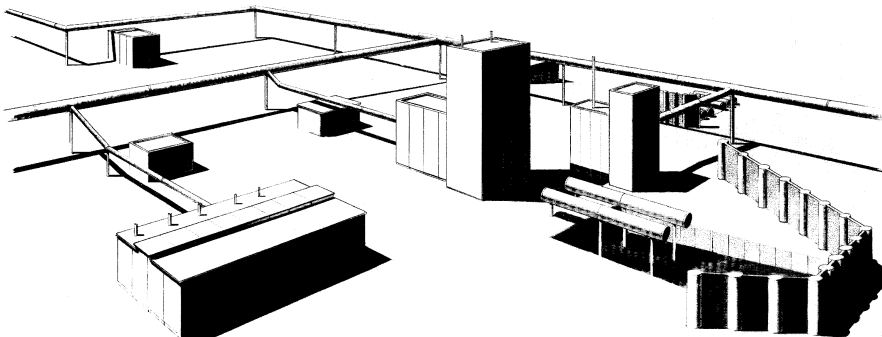
FIGURE 12. ARTIST'S CONCEPTION OF PROBABLE ALTITUDE SIMULATING TEST FACILITY (items 17 and 18, Figure 8).

Items 17 and 18 are the most prominent structures in another test complex (Figure 12). The complex includes 1 large towerlike building (item 18), a small towerlike building, a large building which could house compressors or be used for assembly operations (item 17), 4 smaller buildings (including item 22) whose purposes cannot be determined, and a large array of probable horizontal pressure tanks. The test stand proper (item 18) consists of a 2-level structure, the higher section of which is nearly 60 feet high; the lower section on the north side is about 30 feet high. Two large, horizontal, apparently cylindrical objects extend from the south side of the tower; the tanklike objects measure 50 by 5 feet each and are elevated about 10 feet above local grade level. A concrete-lined sump or pit under the cylinders extends north toward, and possibly under, the test stand and south to a 3-sided, [redacted] high ribbed concrete wall. The [redacted] photography revealed possible blast marks in the form of dark discolorations on the bottom of the pit. A large semiburied tank measuring 86 feet in diameter is located approximately 150 yards east of the test complex. This complex of structures and equipment which are functionally related is probably a "hot-fire" altitude simulating test facility for either engines or upper stages.

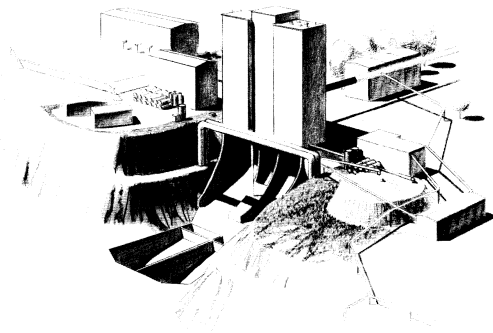
FIGURE 13. ARTIST'S CONCEPTION OF 2-POSITION TEST STAND (items 29, 30, and 31, Figure 8).

Items 29, 30, and 31 are the principal structures in a "hot-fire" rocket engine test complex (Figure 13). Item 29 is probably the checkout building for the 2-position test stand (item 31); item 30 and a similar structure immediately east of the test stand appear to be support buildings for the stand. Each of these support buildings has a large array of probable horizontal pressure tanks; one may pressurize the fuel supply and the other, the oxidizer. The 2-position test stand consists of 3 vertical bays, the outside 2 being the firing bays and measuring 80 feet high. Twin flame deflectors, possibly cooled by a pair of large overhead water supply pipelines, extend out and down from the 2 firing bays to a point approximately 40 feet below the local grade level. A sump extends south from the lower end of each deflector for about 70 feet; these sumps are about 5 feet deep and enclosed on all 4 sides. The center section of the test stand, probably the service bay, is slightly taller than the firing bays, measuring []. A large buried tank measuring [] in diameter is directly east of the test stand and connected to it by piping; this tank is probably used for fuel storage. A probable control/observation structure is located immediately south of item 30.
